LESSONS LEARNED FROM THE FLORIDA HURRICANES

The Roofing Industry Committee on Weather Issues (RICOWI) dispatched seven teams to investigate damage after Hurricane Charley hit the U.S. on August 13, 2004, and five teams after Hurricane Ivan made landfall on September 16, 2004. Often, the roof damage witnessed was caused by omissions in installation and design that a good consultant knows could cause problems in high winds. When these fundamental installation details were absent, there was roof damage. In this article, members of the investigation teams provide limited discussion on fundamentals that will help keep the roof covering in place in high winds.

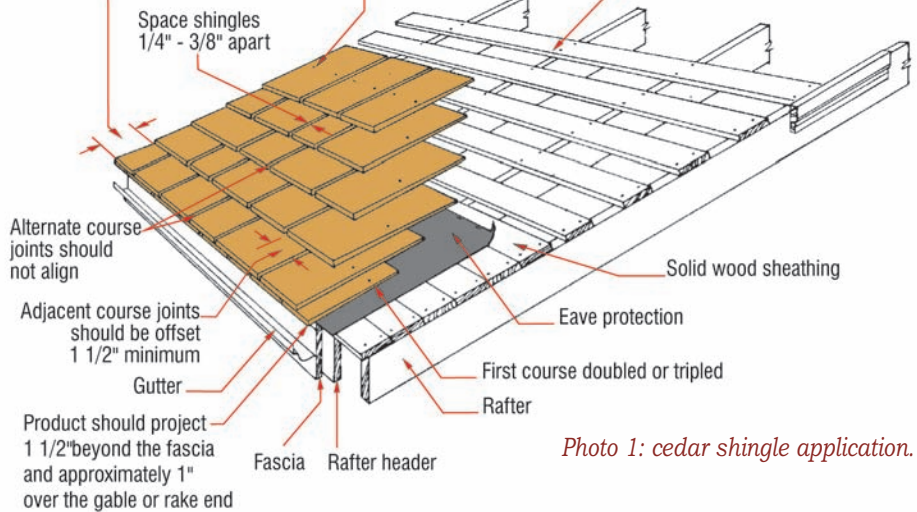
Photo 1: cedar shingle application.

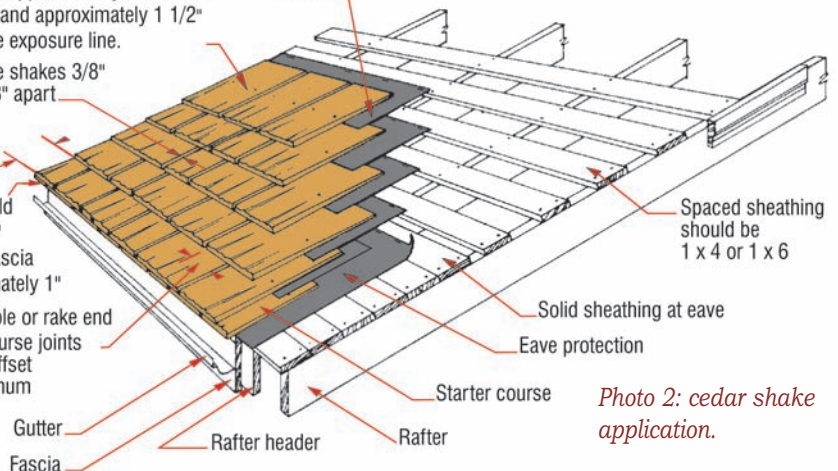
Photo 2: cedar shake application.

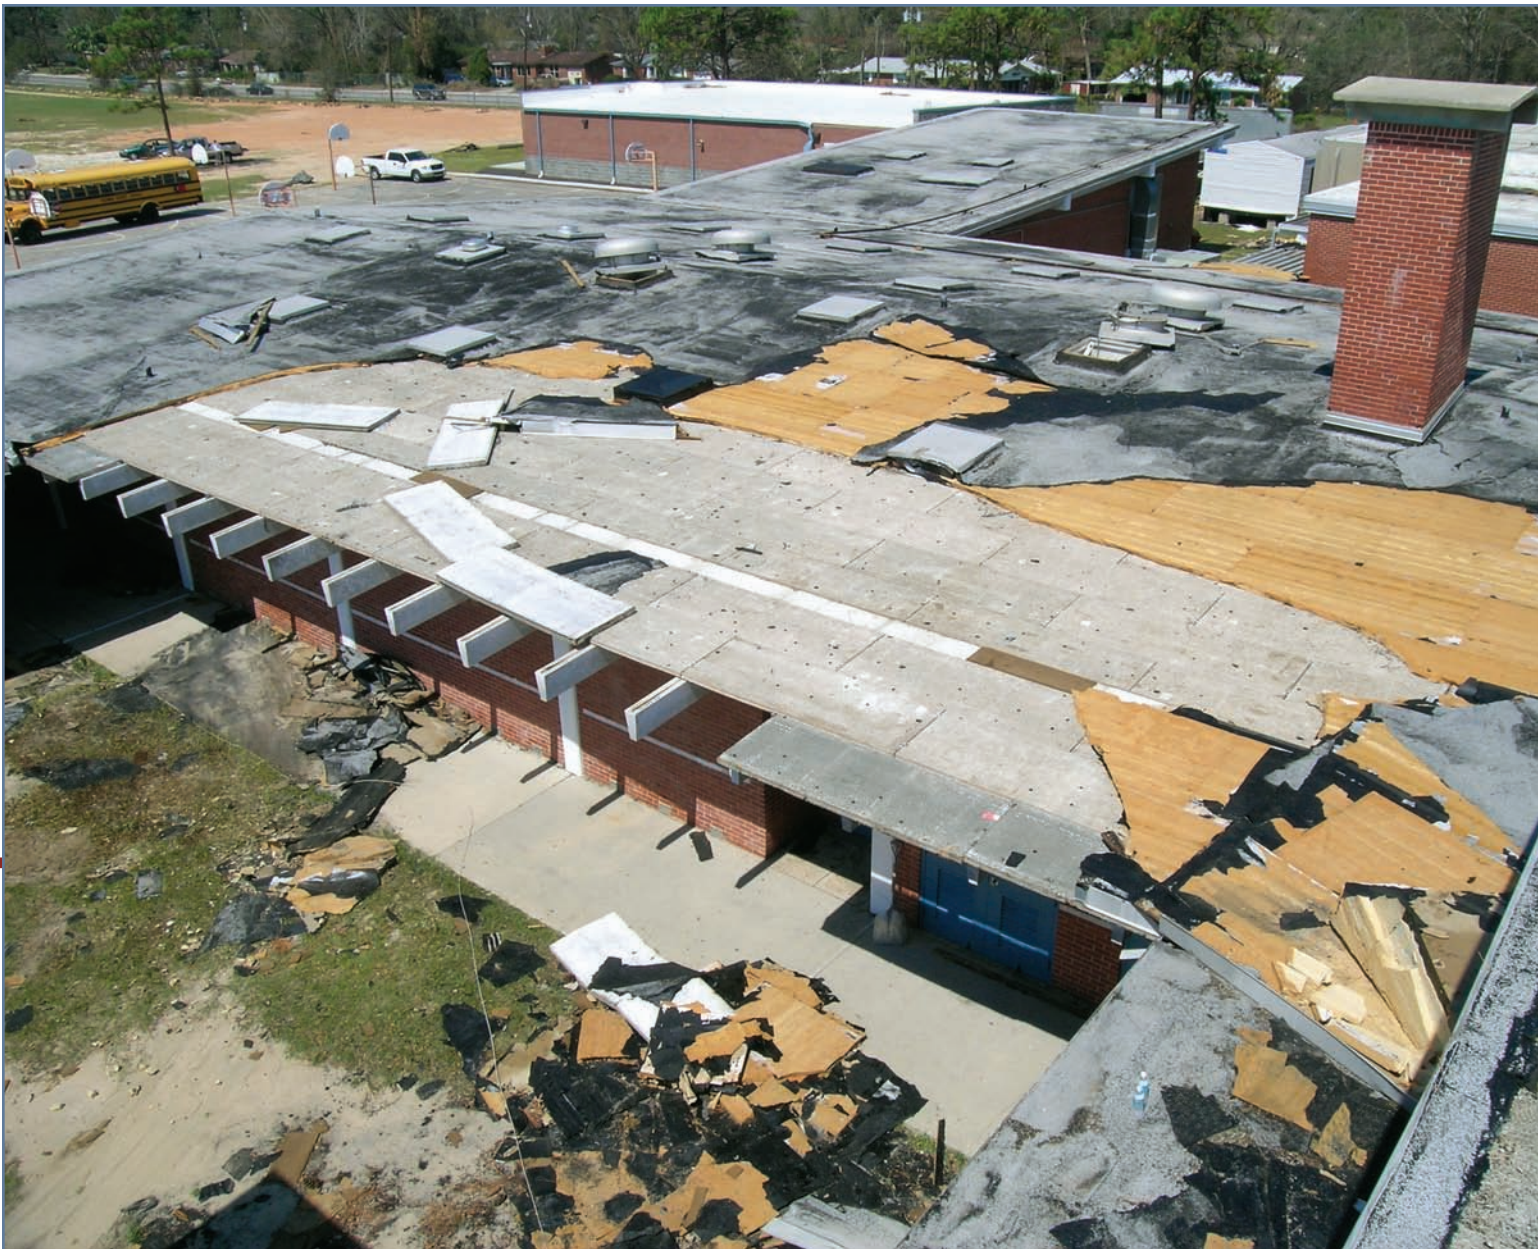
Photo 3: Overhangs increase uplift pressure. Special design is required.

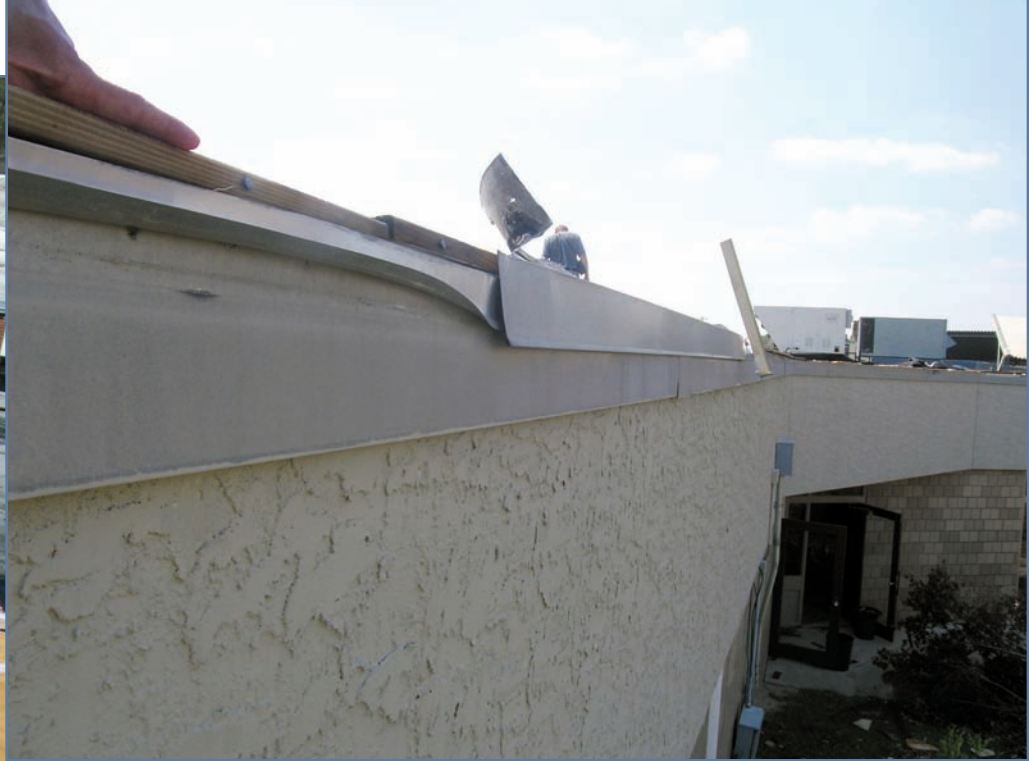
Photo 4: Typical metal edge damage.

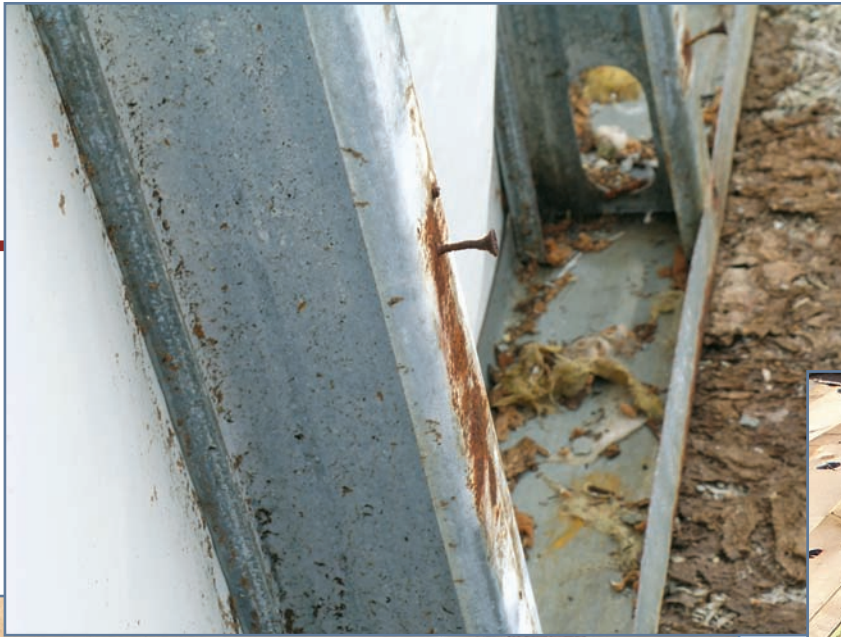
Photo 5: Corrosion is common in hurricane prone areas – especially near the ocean.

4. Use highly durable materials as part of roof attachment systems (e.g., stainless steel or corrosion protected fasteners, preservative treated wood).
5. In hurricane-prone zones, make sure additional perimeter and corner securement as required by Factory Mutual or the membrane supplier is in place. It is advisable to add a secondary securement strap that significantly exceeds the potential uplift load within three feet of the perimeter on membrane roofs to avoid damage.

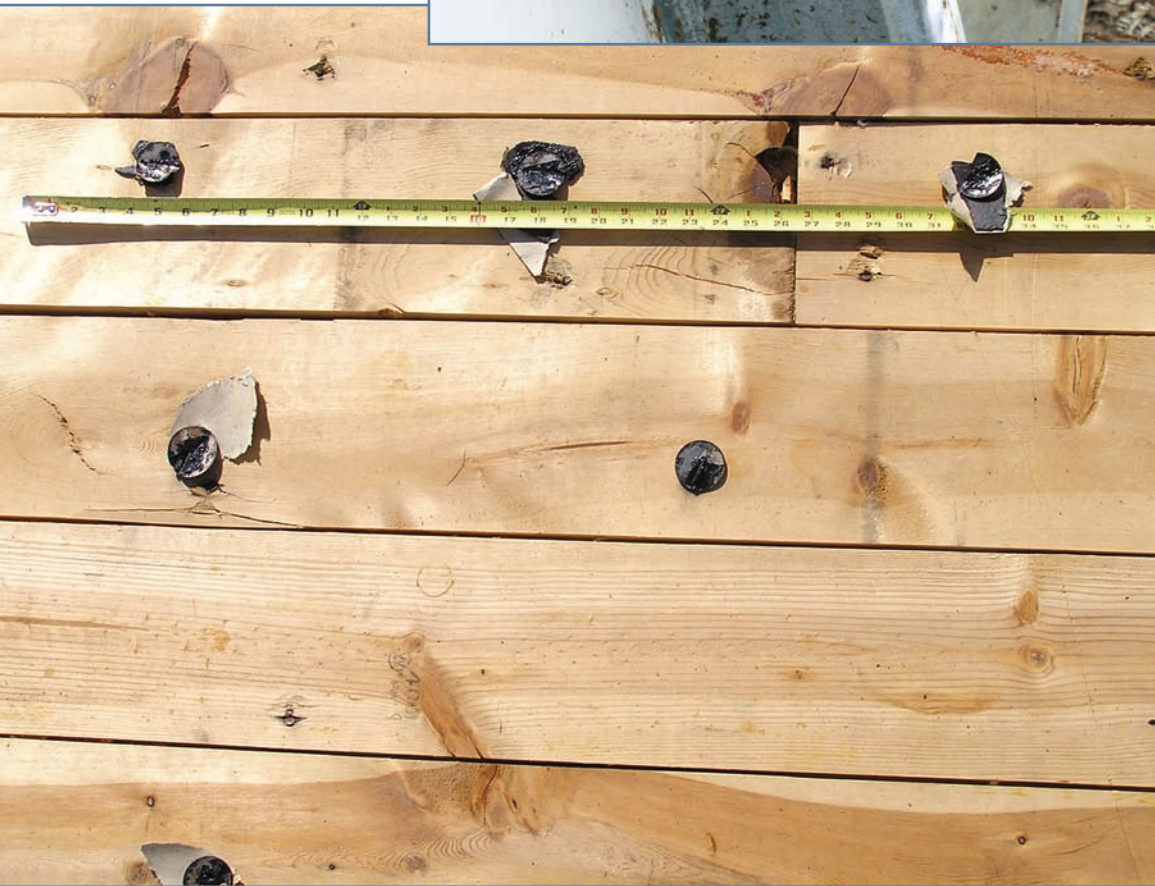
Photo 6: Old BUR attachment. Improper nailing of base sheet did not provide adequate attachment for BUR or new SPF roof system. Side lap nailing is typically 9" O.C.

2. Cut the existing BUR to determine its attachment, and add fastening as necessary.
3. Without cutting the existing BUR, consider adding screws and discs to the 10-foot perimeter at the rate of

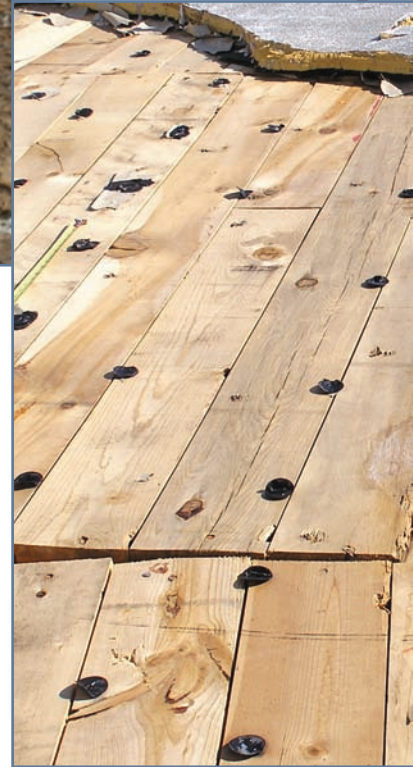
Photo 7: Edge flashing failure – SPF roof system depended upon attachment to rotten edge nailer.

The practice of reusing existing BUR edge flashing routinely resulted in failure.

1. Remove all edge flashing, inspect nailers and replace as necessary, and install new edge metal fastened in accordance with industry standards.

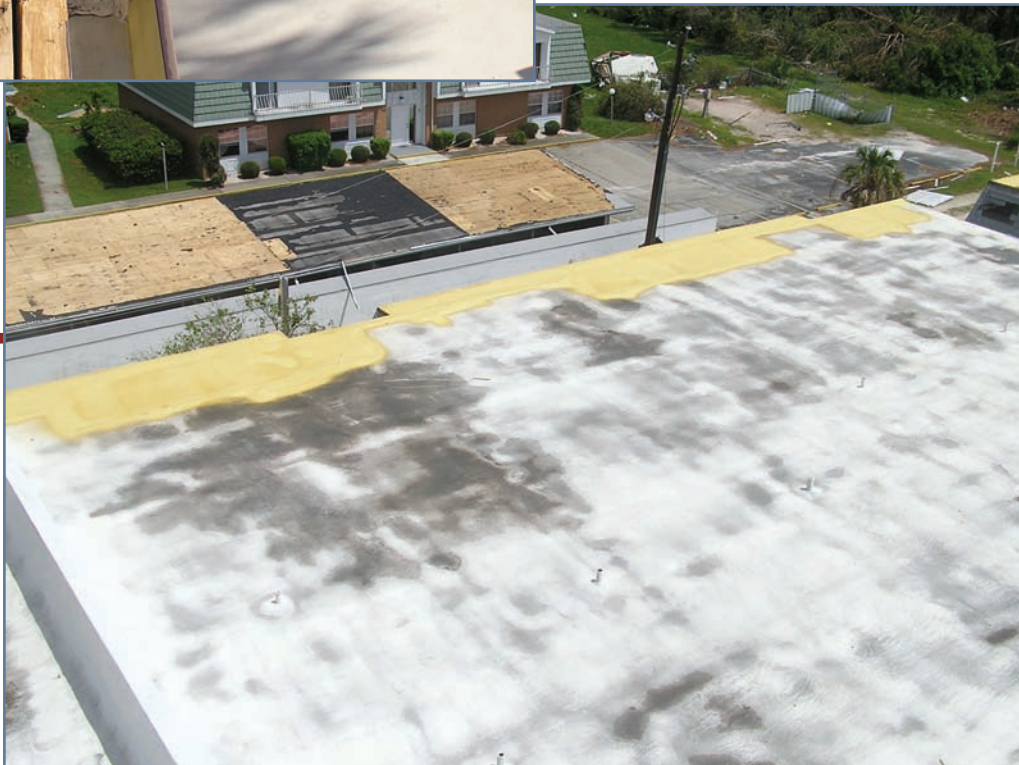
Photo 8: SPF edge repair – Adjacent BUR blew off, while the SPF roof only suffered perimeter damage due to inadequate nailing of metal edge flashing.

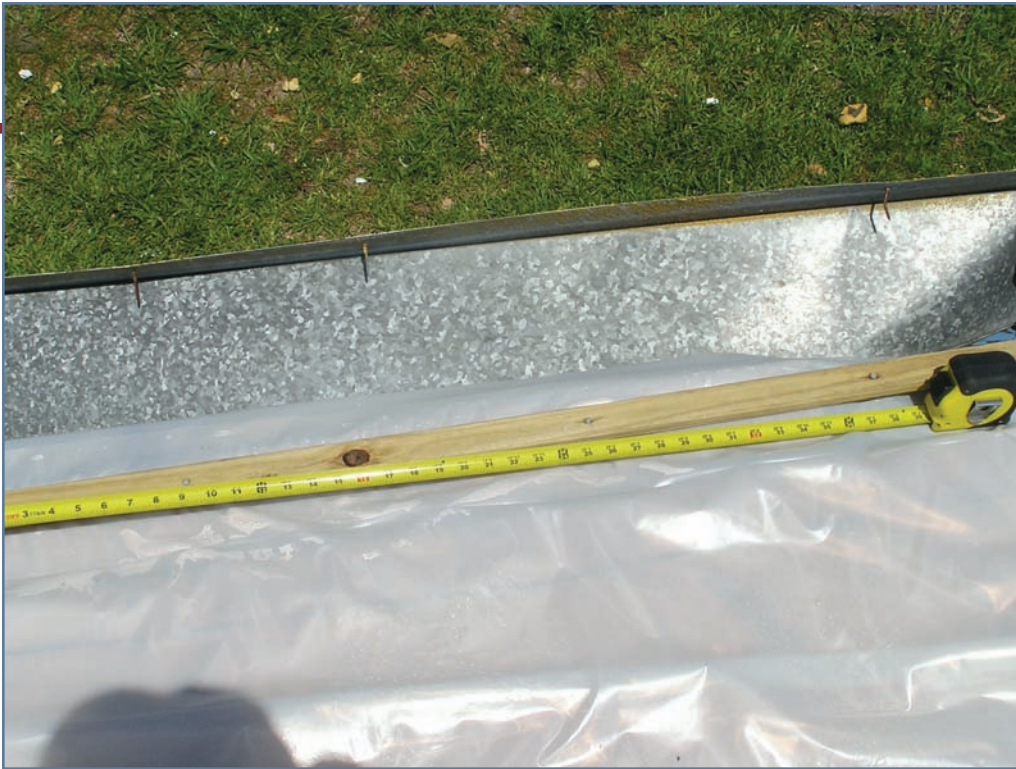
Photo 9: Edge flashing attachment – metal edge improperly fastened at up to 22" O.C.

SPF roofs over BURs were found with rotten edge nailers and metal flashing fastened at 12" on center and greater. Blown off existing BURs with SPF roofs were seen with base sheet fastening substantially less than the industry recommended patterns. Minor missile damage to the coating and SPF was observed, but this damage was not the source of leaks and could have been repaired with a tube of sealant.
