LESSONS LEARNED FROM THE FLORIDA HURRICANES

The Roofing Industry Committee on Weather Issues (RICOWI) dispatched seven teams to investigate damage after Hurricane Charley hit the U.S. on August 13, 2004, and five teams after Hurricane Ivan made landfall on September 16, 2004. Often, the roof damage witnessed was caused by omissions in installation and design that a good consultant knows could cause problems in high winds. When these fundamental installation details were absent, there was roof damage. In this article, members of the investigation teams provide limited discussion on fundamentals that will help keep the roof covering in place in high winds.

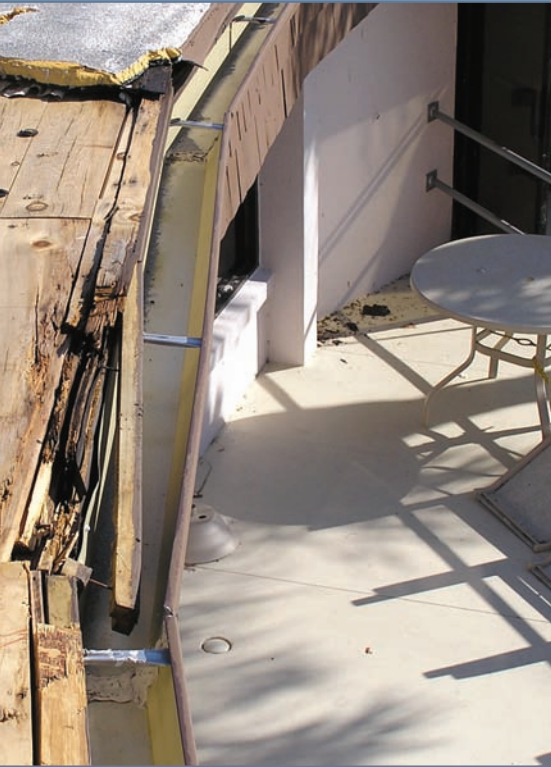
Photo 8: SPF edge repair – Adjacent BUR blew off, while the SPF roof only suffered perimeter damage due to inadequate nailing of metal edge flashing.

1. Remove all edge flashing, inspect nailers and replace as necessary, and install new edge metal fastened in accordance with industry standards.
